WAKULLA SPRINGSWATCH MONITORING SUMMARY

January - December 2022

PREPARED FOR
FLORIDA DEPARTMENT OF ENVIRONMENTAL PROTECTION,
DIVISION OF RECREATION AND PARKS

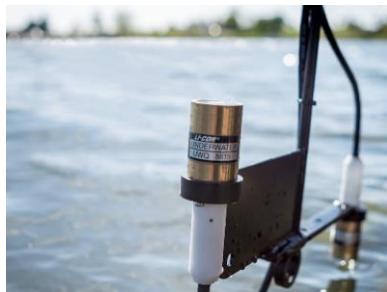
Figure 2. LI-COR LI-250A Photometer

Photosynthetically Active Radiation (PAR) underwater light transmission and attenuation coefficients were measured monthly at the 15 monitoring sites. Volunteers used a LI-COR brand LI-250A underwater quantum photometer to measure PAR energy reaching the water surface and at depth intervals of one foot and two feet. Figure 2 provides an image of the LI-COR photometer.

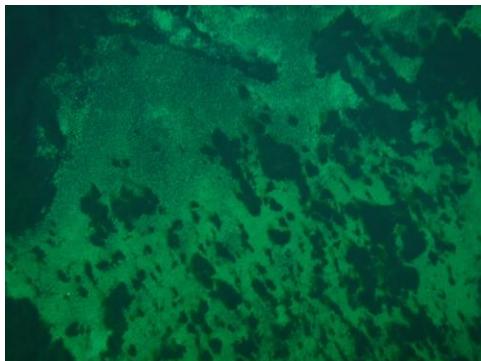
Algae and bare ground at head spring

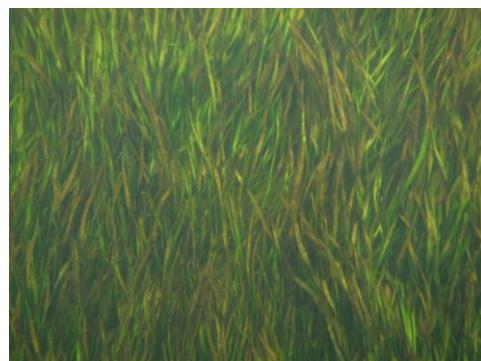
Strap-leaf *Sagittaria*

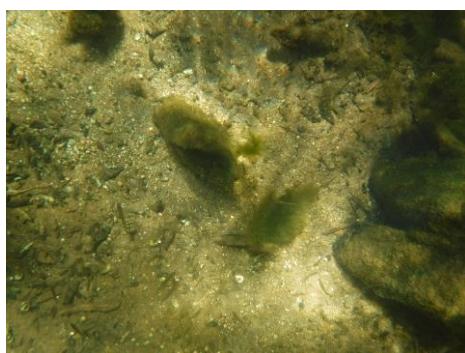
Bare ground and algae

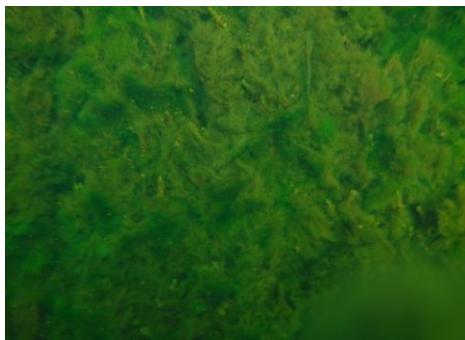
Hydrilla and algae

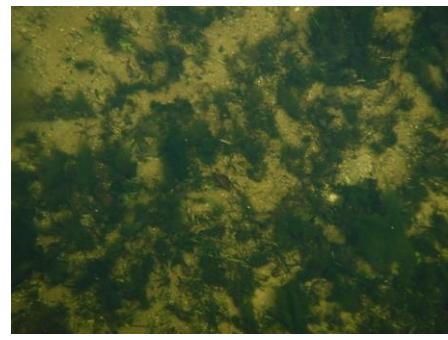
Algae and bare ground
