KINGS BAY SPRINGSWATCH MONITORING SUMMARY

June 2023— December 2023

Howard T. Odum
**FLORIDA
SPRINGS
INSTITUTE**

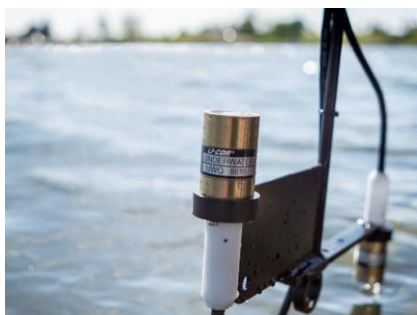
Figure 2. LI-COR PAR light sensor

Photosynthetically Active Radiation (PAR) underwater light transmission and attenuation coefficients were measured monthly at the seven monitoring sites. Volunteers used a LI-COR brand LI-250A underwater quantum photometer to measure PAR energy reaching the water surface and at depth intervals of one foot and two feet. Figure 3 provides an image of the LI-COR PAR light sensor.

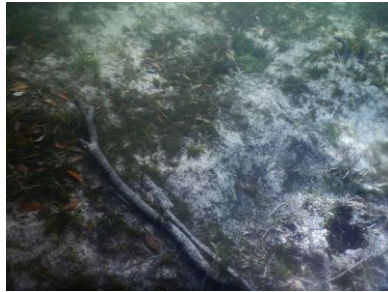
KB-2

Pictured below are river bottom photos taken by Kings Bay SpringsWatch volunteers in 2023 which feature the SAV of the seven springs stations. Volunteers were unsuccessful in taking photos at stations KB-1 and KB-3 either due to spring closure for manatee season or low visibility.
